Remedial Investigation Report

Libby, Montana

Operable Unit 5 Libby Asbestos National Priorities List Site

Prepared for
US Environmental Protection Agency

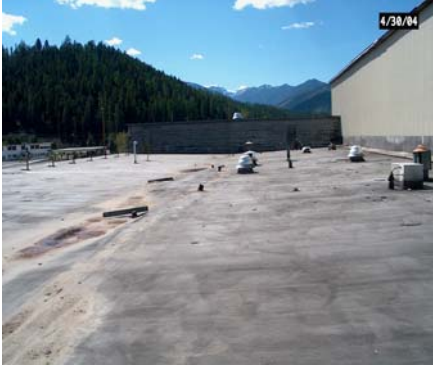
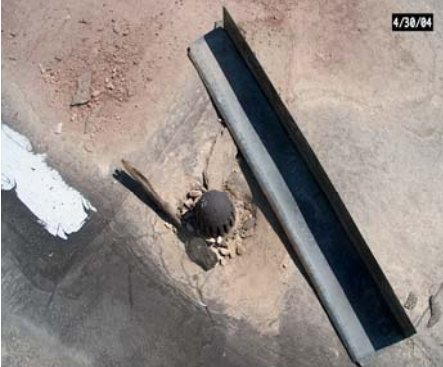
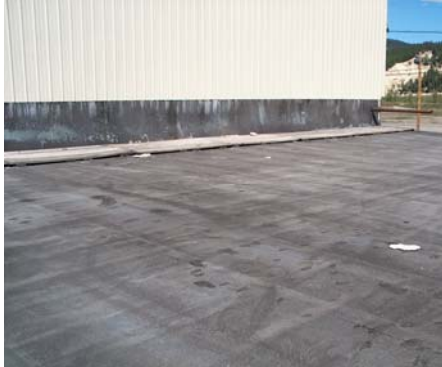
<p>Lower roofs, facing west – these roofs are not damaged – the northern half has VCBM, southern half does not.</p>	<p>VCBM is seen as both debris and pulverized into powder, collecting at low points including around pipe penetrations (vents).</p>	<p>A row of pallets lines the edge of the lower roof adjacent to the Former Mobile Shop. These are to be washed and returned to their original location.</p>

- The following roof areas will be surface vacuumed after the completion of the upper roof: entire lower (Former E&W Area) roof including the roof area west of the upper roof and the raised roof area that is approximately 10 feet higher than the lower roof area. See Figure 3 for locations. Mechanical means may be used in these areas as well. The only roof area not requiring vacuuming is the Former Lift Truck Barn roof.

- The pallets that line the edge of the Former Mobile Shop on the lower roof will be washed to remove all surficial material and returned to their original location.

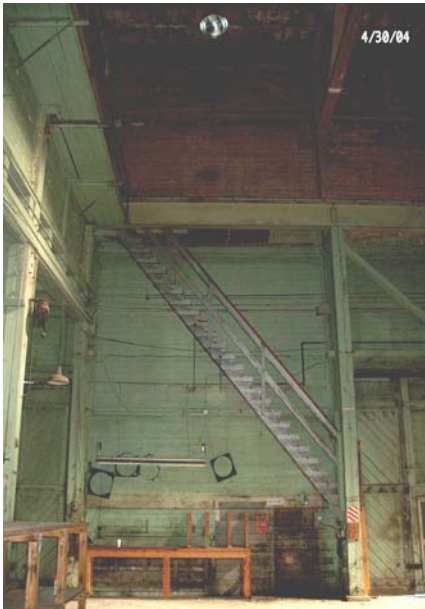
North side bay 13, note obstacles to work area. The stairway accesses the catwalk on the west side of the Former Mobile Shop.

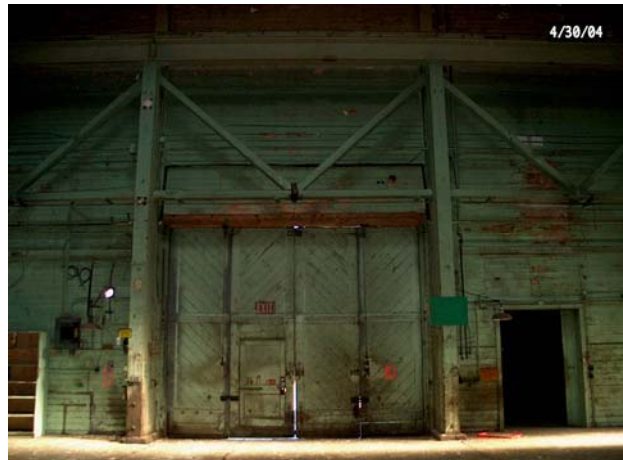
North side bays 11, 10, 9 from left to right. A door and solid wall are at lower section of bay 10, Wall cavities with VCI are in all of bays 9 and 11. Trusses for crane track in front of all wall bays.

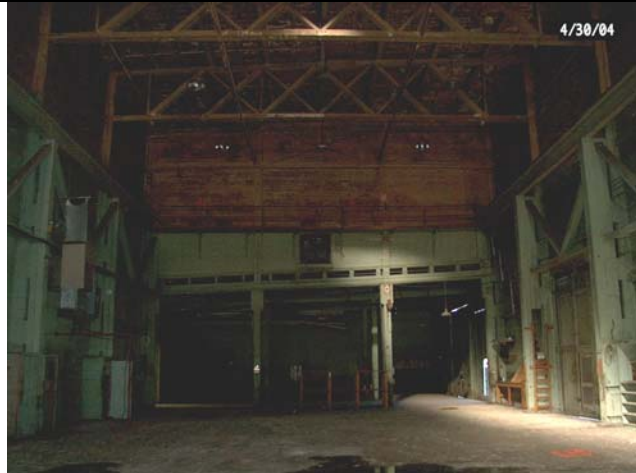
West wall of the Former Mobile Shop. The catwalk is located where the color changes from green to brown. Steel bracing is at the ceiling in northeast and southeast corners, but is not visible in this photo.

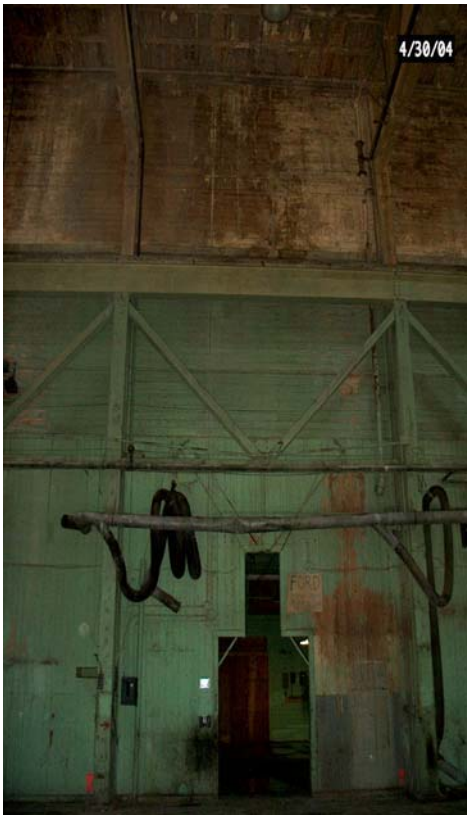
Typical south bays, photo shows bays 8 and 9. The lower 19 ft. wall sections are solid in all south bays.

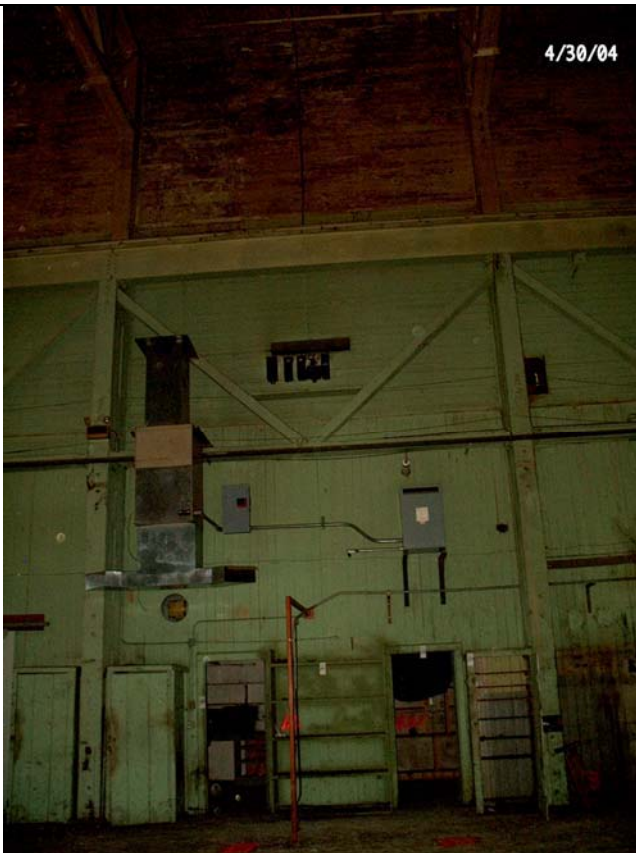
South side bay 12, showing some of the typical obstacles, penetrations, and utilities in the work areas.

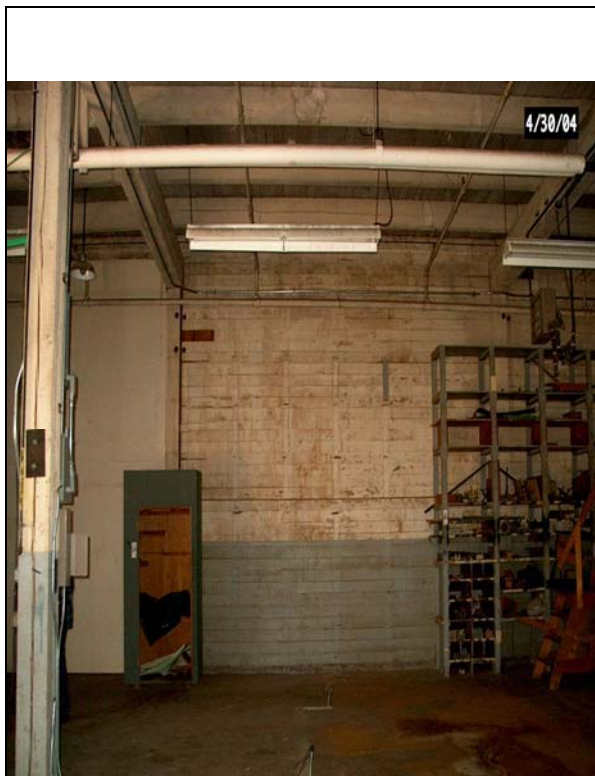
Room 1-1 (Fig 1). Midline wall. Walls in this room are accessible from a stepladder. These walls may contain full or remnant VCI.

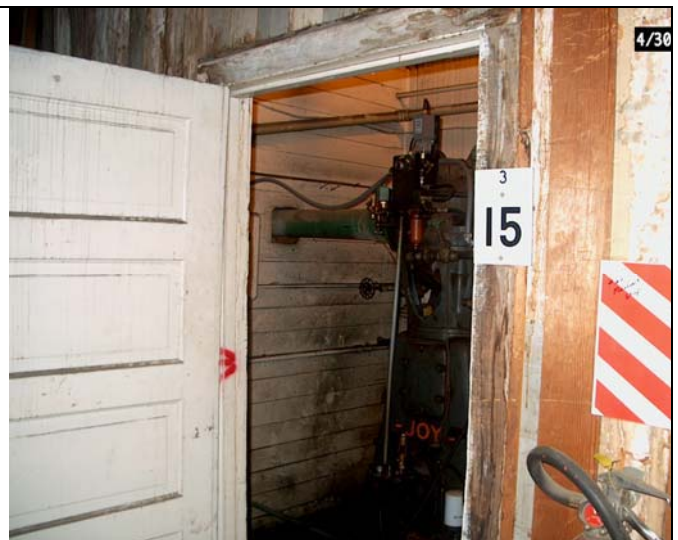
Room 17-2. These walls have full or remnant VCI, and are in a small room with a fixed furnace.

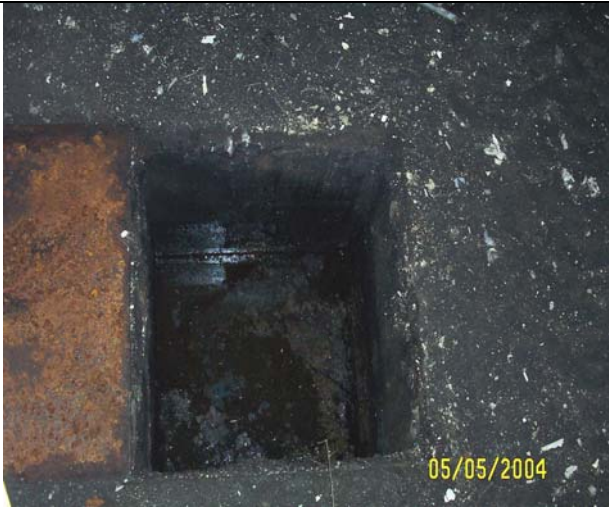
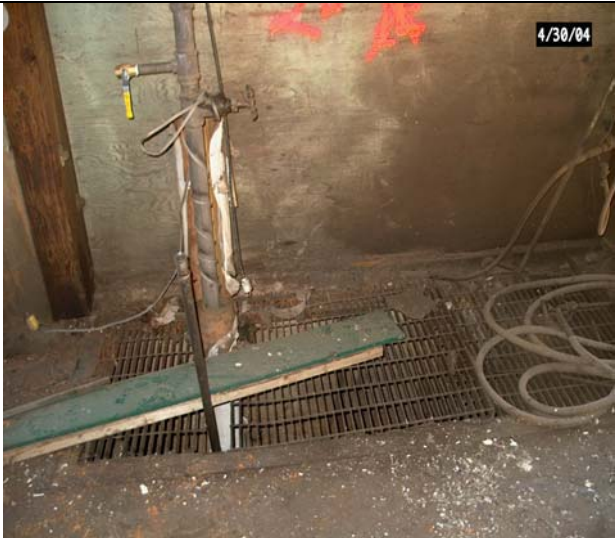
<p>Some vaults have water/sludge and do not require cleaning.</p>	<p>This pit is dry and has some debris, requires cleaning by disposing of debris and vacuuming pit. This is at the middle of east wall.</p>

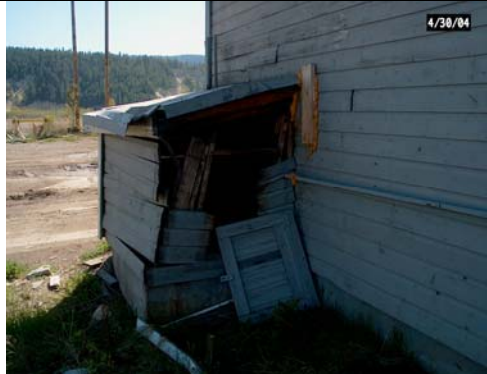
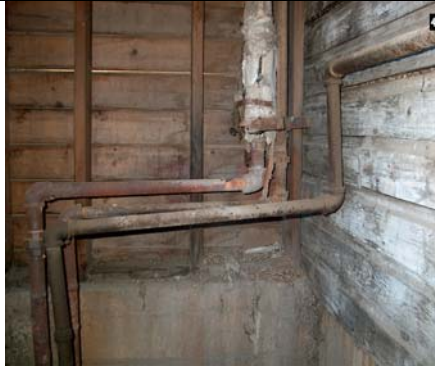
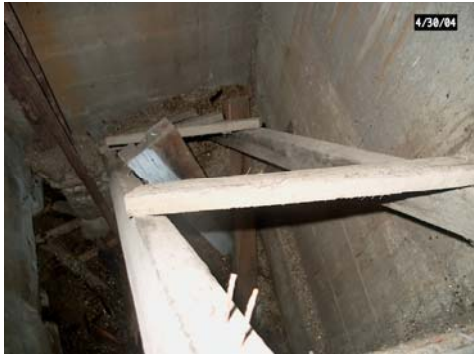
<p>The shack is located on the east end of the north side of the Former Mobile Shop (refer to Fig 2), and has VCI inside and on the ground outside. The shack will be dismantled and discarded.</p>	<p>Inside the shack – piping with remains of suspect ACM insulation. The insulation will be discarded as ACM.</p>	<p>Looking into the vault – VCI is scattered throughout this area – discard all debris within this vault – wash down and surface vacuum interior, apply encapsulant.</p>

- The shack will be dismantled prior to entry to ensure the safety of workers.
- The shack materials will be properly disposed of as ACM.
- Piping inside the shack will be protected and supported, as necessary.
- All suspect ACM insulation from the pipes will be removed and properly disposed.
- The vault located in the floor of the shack will then be remediated. Confined space entry procedures may be applicable for entry into this vault. Any debris inside the vault will be discarded as ACM.
- VCI within the vault will be removed with vacuum methods.
- Encapsulant will then be applied to the walls, floor, and piping within the vault.

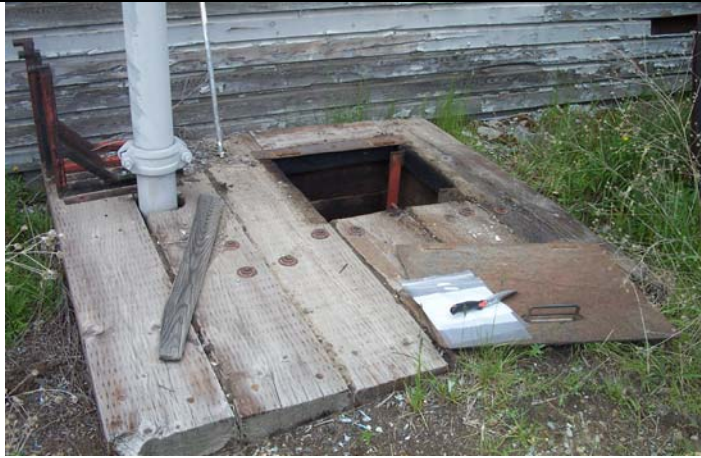
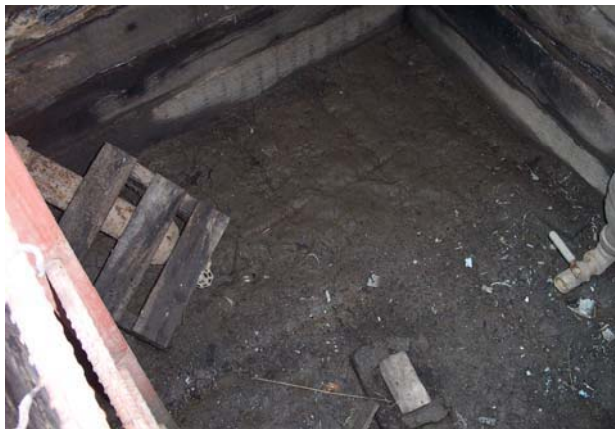
<p>Entrance to vault on the south east corner of the building. The Vault has creosote timber walls and a soil floor.</p>	<p>Floor of the vault as viewed from the entrance.</p>

- The vault on the southeast corner of building has vermiculite in the soil floor. However, soil samples reveal that LA asbestos is non-detect. Therefore, no remediation will be required to the soil floor of the vault.
- Any remnant VCI located on the surface of the soil floor will be vacuumed.
- Confined space entry procedures may be applicable for entry into this vault.

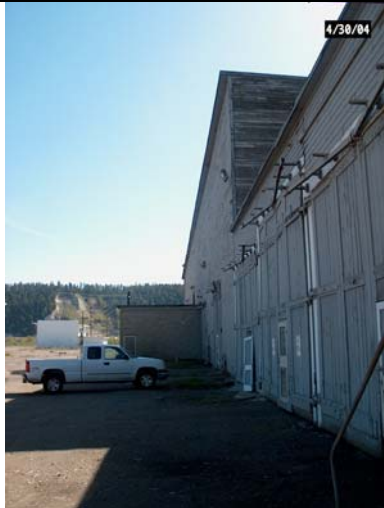
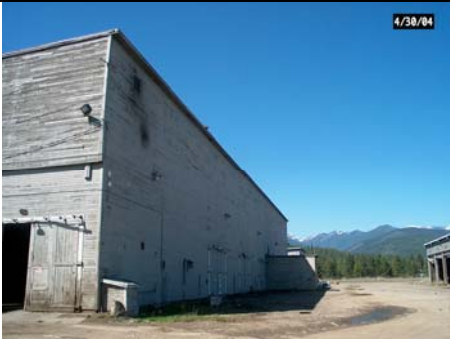
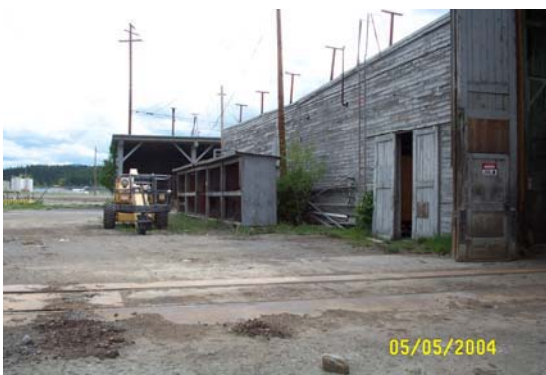
North side of Former Mobile Shop facing west, from the east end.	North side of Former Mobile Shop facing east, from the west end.	East side of Building, note the shed/shelves and pipe rack against the wall – the shed has no floor.

- Excavation along the perimeter of the building will not be required, as analytical results of soil samples taken in the perimeter areas reveal that LA asbestos is non-detect.
- However, surficial VCBM and VCI located on the top of the soil along the north and east sides of the building will be removed by vacuum methods, from the edge of the walls and outward approximately 45 feet.
- Items located within the work area, such as the racks and shelving will be left in place and protected during surficial removal.

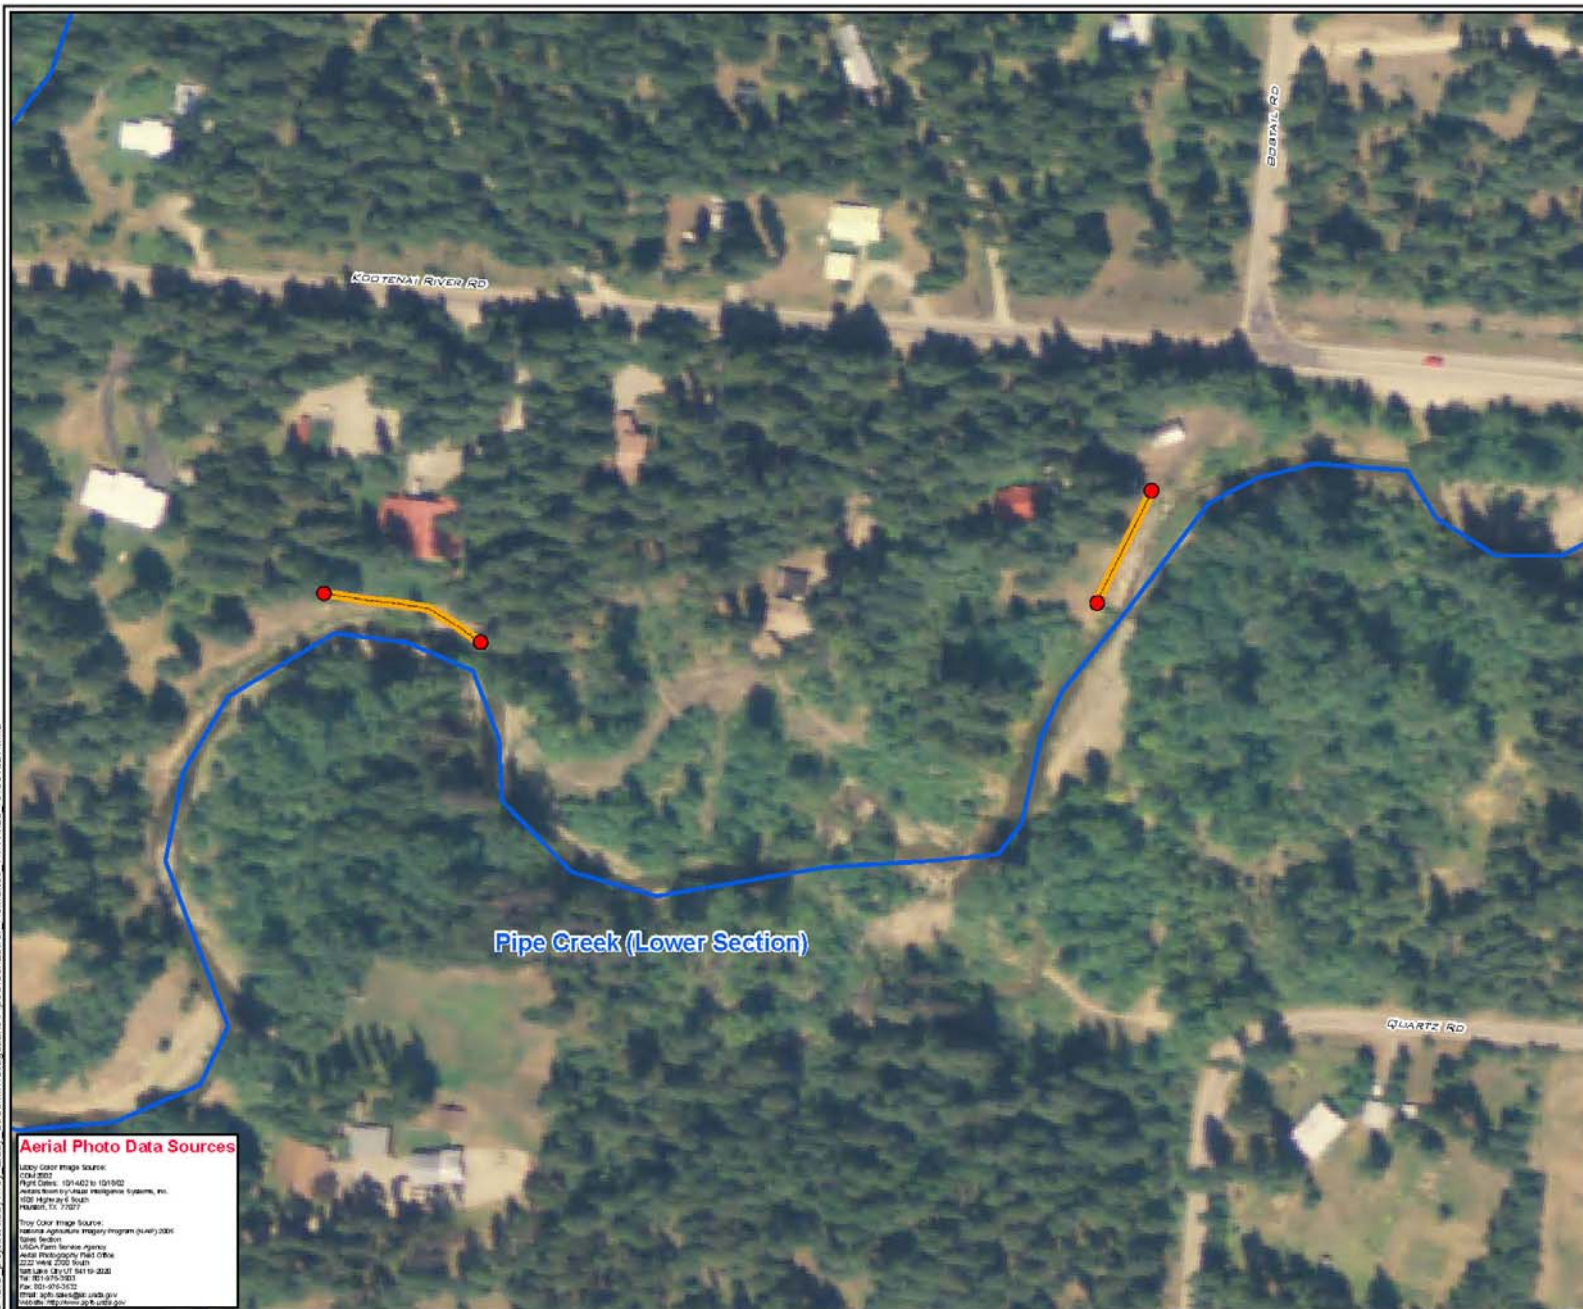
Troy Area Creek Investigations
Libby Asbestos Site
Libby, Montana

- — ● Areas Requiring Remedial Action
- ~ Portion of Creek Investigated

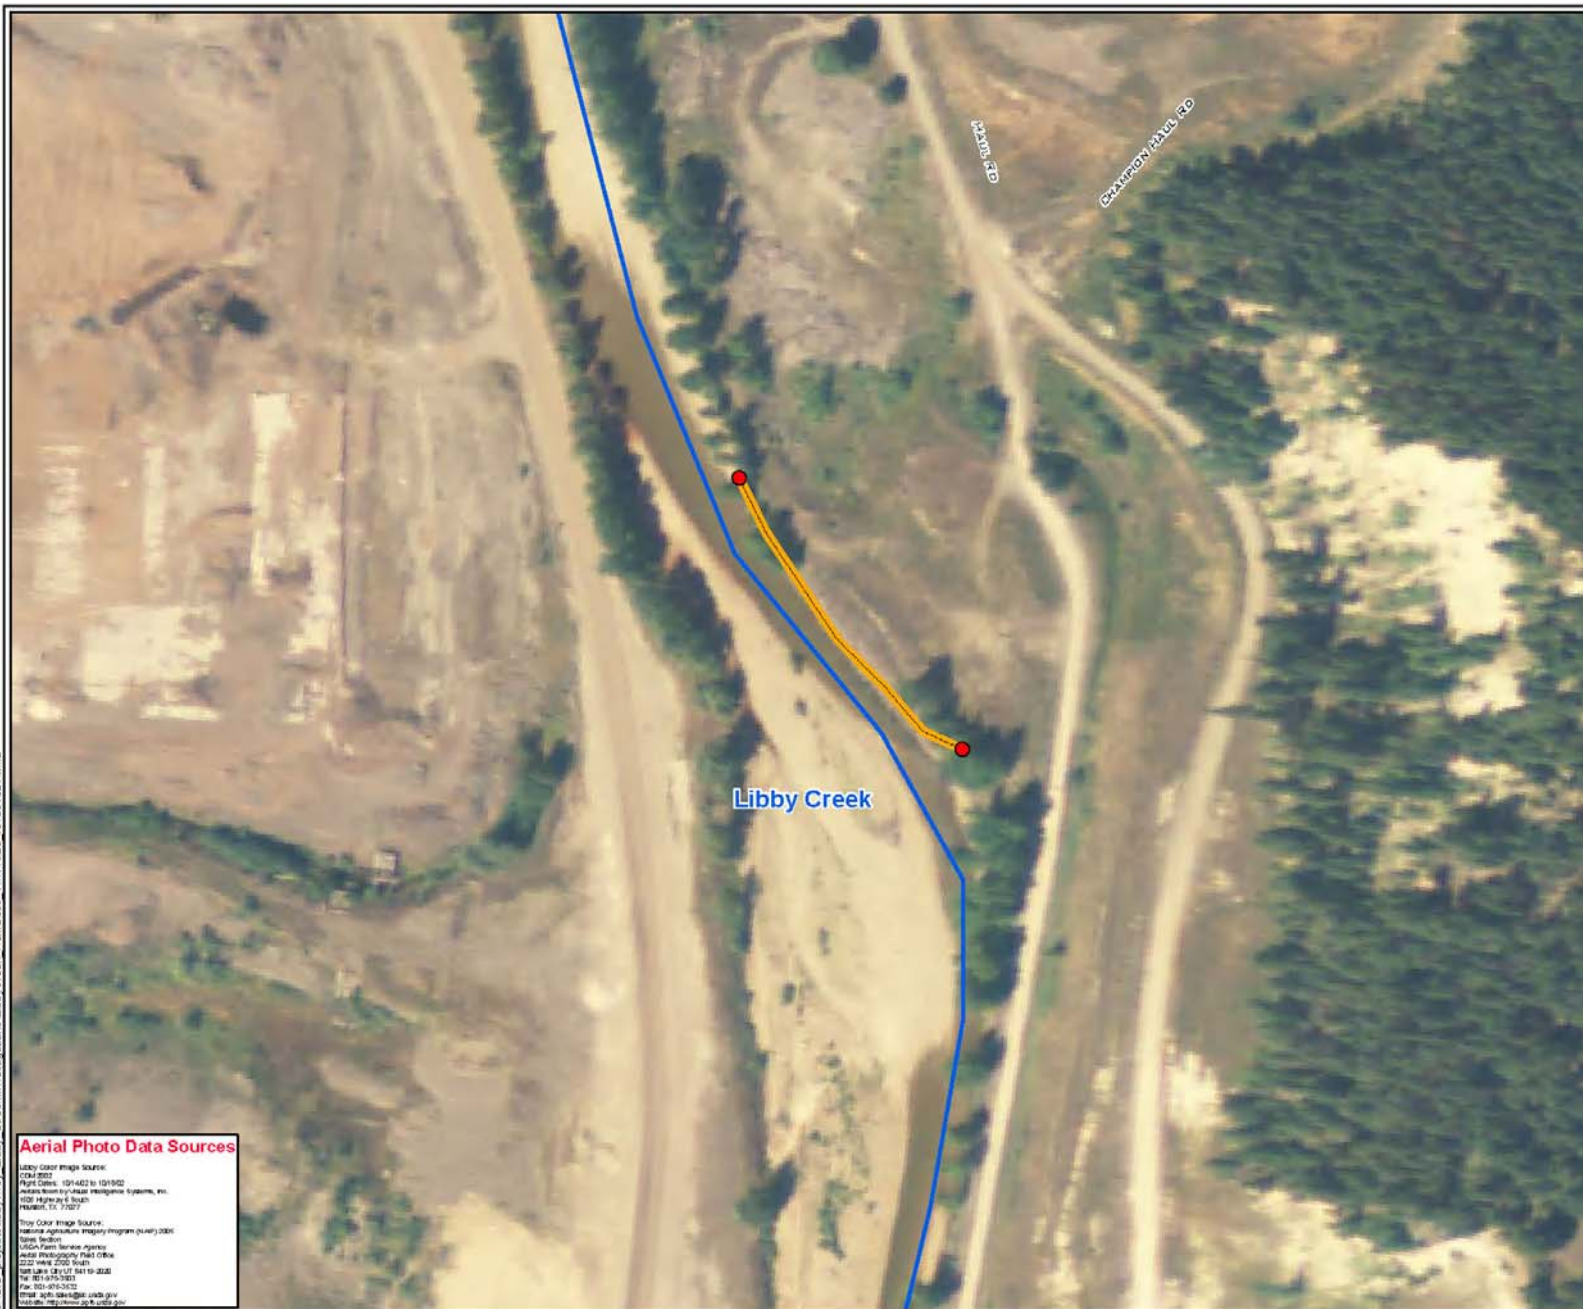
Pipe Creek (Lower Section)
 Remediation Areas
 Libby Asbestos Site
 Libby, Montana

●—● Area Requiring Remedial Action

~~~~~ Portion of Creek Investigated
